Meistertip Tech Tip

Funkenflug und Industriestaub Industrial Fall – Out

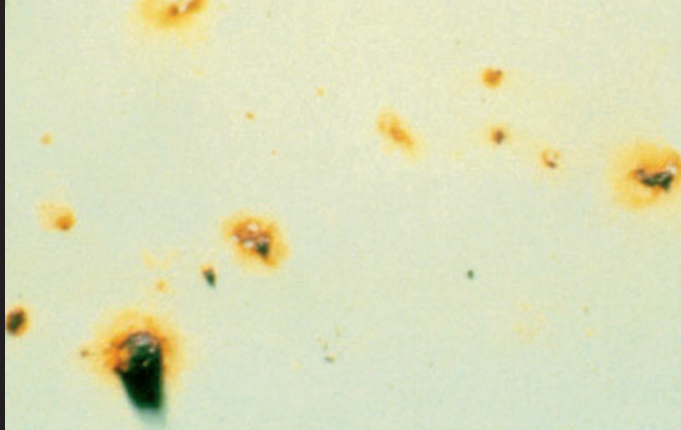
Funkenflug: das Einbrennen von heißen oder glühenden Teilchen auf der Oberfläche. Industrial Fall – Out: the hot and sometimes glowing, particles of iron burn into the paint surface.

Punktförmige Korrosionserscheinungen an der Lackoberfläche.

Industriestaub
Niederschläge aus Kaminen von Gießereien und eisenverarbeitenden Betrieben. Schienenabrieb und Straßensplitt. Eisenpartikel, die hauptsächlich auf liegenden Flächen vorkommen, und bei hoher Luftfeuchtigkeit oxydieren und sich dann in die Lackoberfläche fressen.

Abbrand von Oberleitungen der Straßen- und Eisenbahnen. Funkenflug vom Flexen, Schweißen oder Schleifen. Die heißen, teils glühenden Eisenteilchen brennen sich in die Lackoberfläche ein.

Spots of corrosion on top of the paint surface

Industrial Dust
Corrosive deposits from chimneys of foundries and ironworks. Rail and road chippings. Iron particles, which mainly occur on top flat surfaces, oxidise in moisture and humidity and then attack the paint surfaces.

Ash from overheated electricity cables on tramways and railways. Spark damage from welding and grinding operations. The hot and sometimes glowing, particles of iron burn into the paint surface.

Sofortiges Entfernen der Metallpartikel und regelmäßige Pflege der Lackierung (Konservierung) können zur Vermeidung beitragen. Bei Flex- und Schweißarbeiten umstehende Fahrzeuge bzw. angrenzende Fahrzeugteile abdecken.

Handelsübliche Metallstaubentferner anwenden und evtl. nachpolieren mit Feinpolierpaste. Falls die Metallpartikel tiefer liegen, die Störungen mit P1200 anschleifen und dann aufpolieren mit einer Feinpolierpaste und nachpolieren mit einem handelsüblichen Hochglanzpolish.

Immediate removal of the metal particles and regular maintenance by polishing and waxing will help to avoid the problem. Where welding or grinding work is being carried out, ensure that all vehicles adjacent to or near the work are fully covered to protect them.

Use a metal dust remover and finish off by polishing the surface with Fine Polishing Paste. If the metal particles are deeply etched into the paint surface, sand down the affected areas with P1200 and then polish with Fine Polish Paste and finish with any standard deep gloss polish.
